INSPECTION REPORT: AGED CARE FACILITY - CUBBINE ROAD, CUNDERDIN

INSPECTION OF PREMISES - RECOMMENDATIONS FOR MAINTENANCE AND REFURBISHMENT OF FACILITY:

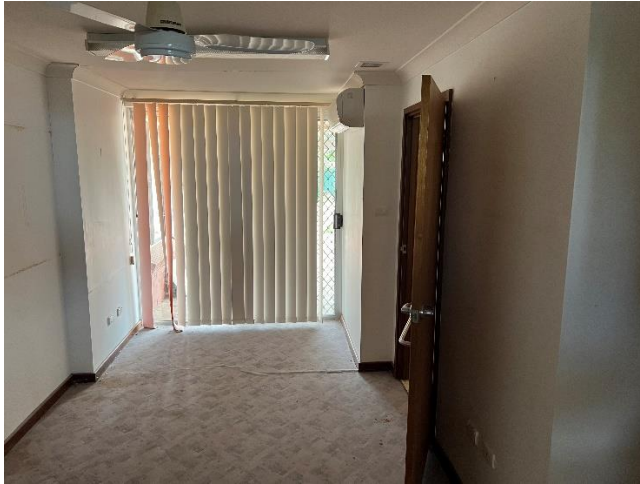
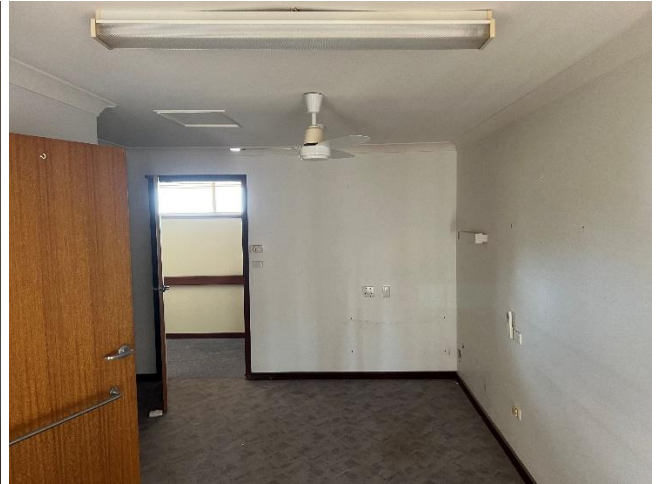
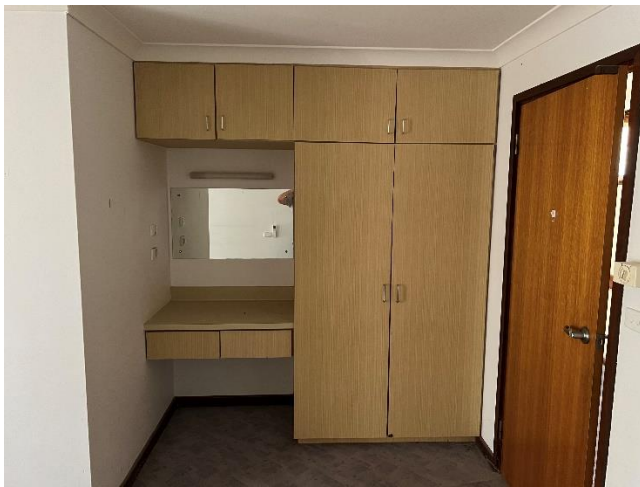
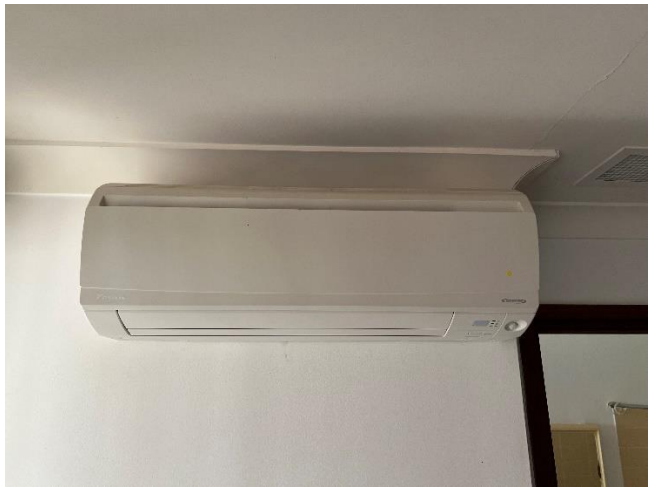
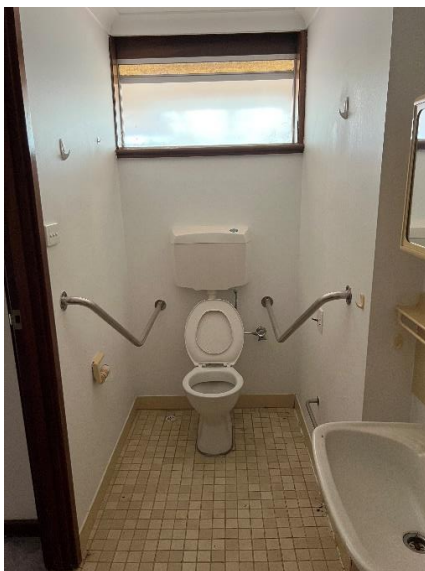
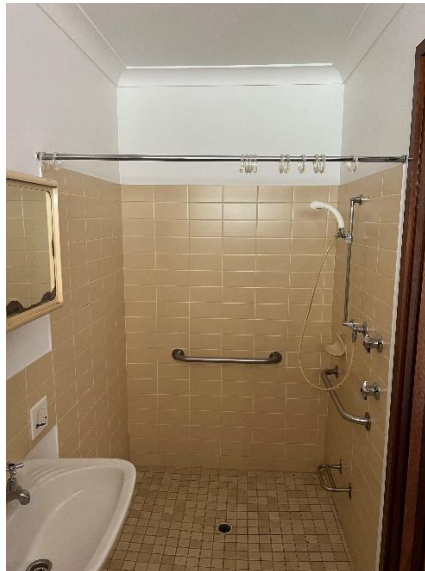
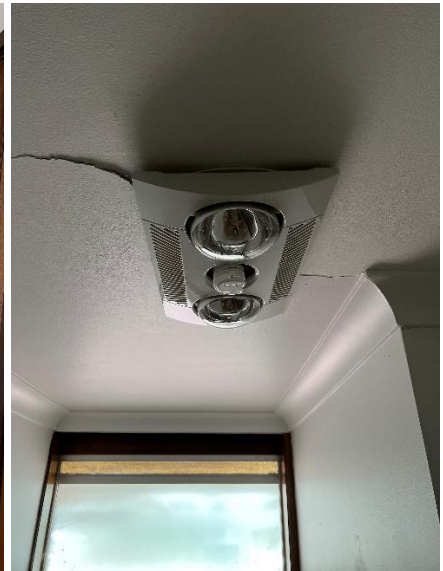
Bedrooms/Ensuites:

1. Bedroom and ensuite ceilings and/or cornice have sustained partial collapse likely as a result of adhesive degradation. The ceilings, including cornice and insulation will require removal and replacement.
2. The removal of ceilings will necessitate disconnection/reconnection of electrics.
3. Lighting and fans require replacement.

4. The bedrooms were previously fitted with a wall mounted King Single bed and current configuration of the room will not allow a Queen or Double Bed (Extra) to be installed.

5. The ensuite bathrooms are aged and not to modern standards requiring refurbishment. Disabled equipment in both the shower and toilet area will require removal. This will necessitate removal of wall tiles and sheeting however the removal of floor tiles and plumbing are not required. Replacement of wall sheeting (Aquachek Gyprock along with Waterproof Membrane) will ensure current Building Standards are met. The removal of tiles and sheeting will allow reconfiguration of the bedroom (see attached drawing) to allow installation of a double or queen bed. This requires some carpentry and plumbing works however will not involve any structural change to the building.

6. Installation of a vanity cabinet and basin will be required.
7. Walls and ceilings will require painting.
8. The glass sliding door has maintenance issues requiring works.

9. Floorcoverings and blinds are worn requiring replacement.
10. Air conditioner units require testing and are likely to require replacement.

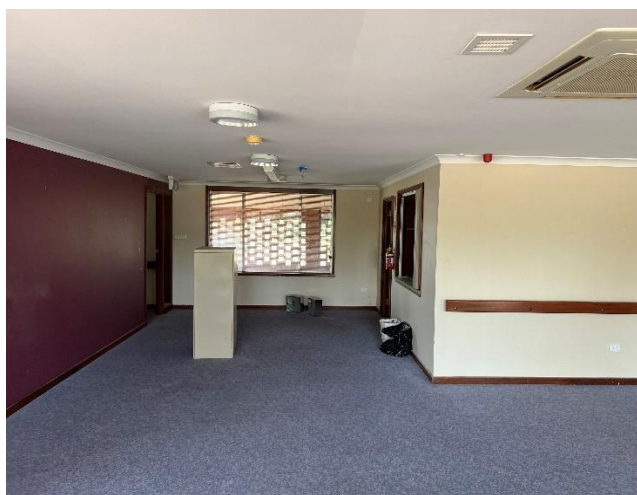
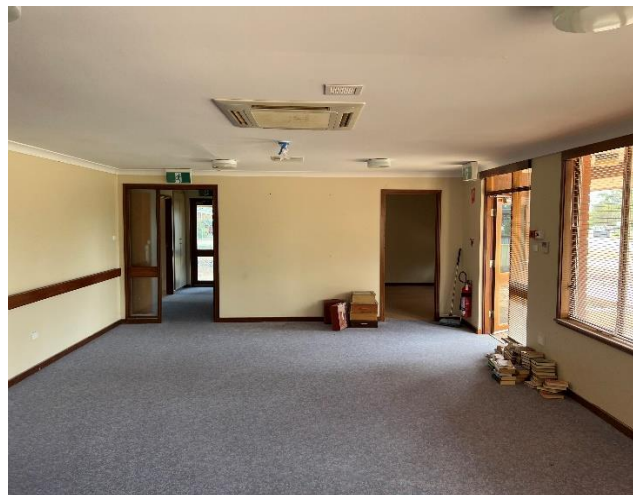
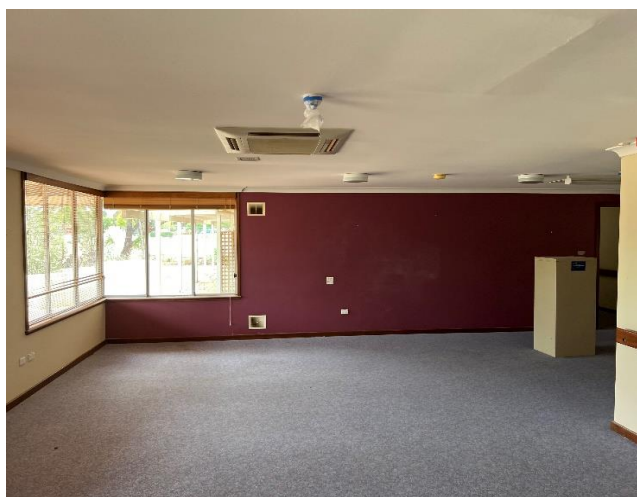
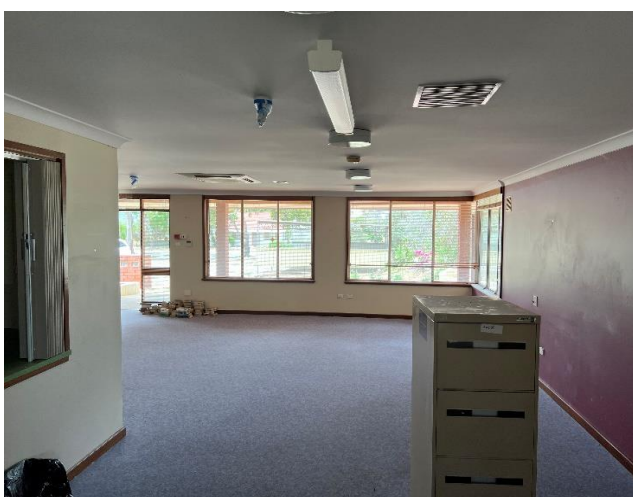
Communal lounge/TV/Dining Room:

1. The lounge ceilings and/or cornice have sustained partial collapse likely as a result of adhesive degradation. The ceilings including cornice and insulation will require removal and replacement.
2. The removal of ceilings will necessitate disconnection/reconnection of electrics.
3. Lighting requires replacement.
4. Walls and ceiling require painting.
5. The carpet and blinds may be serviceable however require commercial cleaning.
6. Air conditioner unit requires testing and is likely to require replacement.

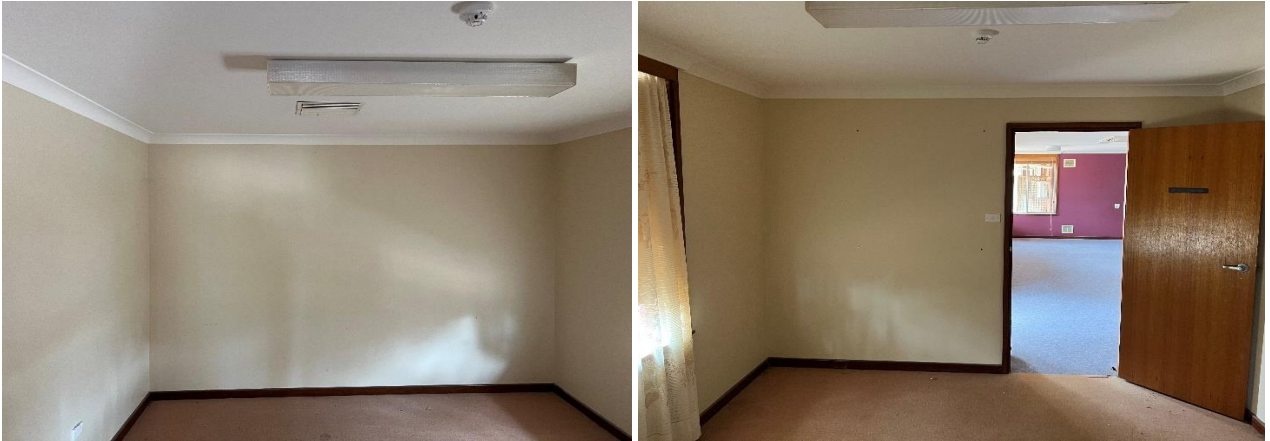
Office:

1. Walls and ceiling require painting.
2. Floorcovering and blinds are worn requiring replacement.
3. Lighting requires replacement.

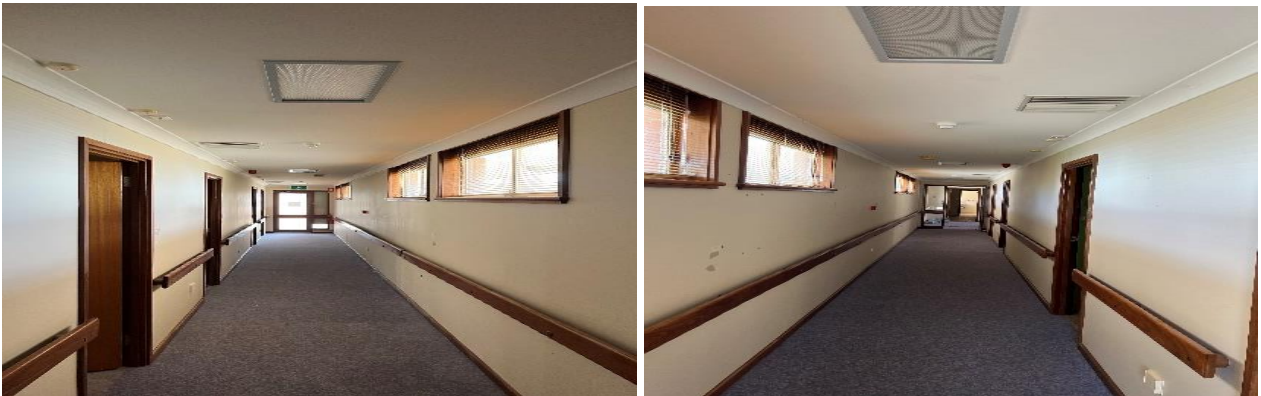
Hallway:

1. The ceiling and/or cornice have sustained partial collapse likely as a result of adhesive degradation. The ceilings including cornice and insulation will require removal and replacement.
2. The removal of ceilings will necessitate disconnection/reconnection of electrics.
3. Lighting requires replacement.
4. Wall rails require removal. Wall will require patching.
5. Walls and ceiling require painting.
6. Floorcovering and blinds appear serviceable however require commercial cleaning.

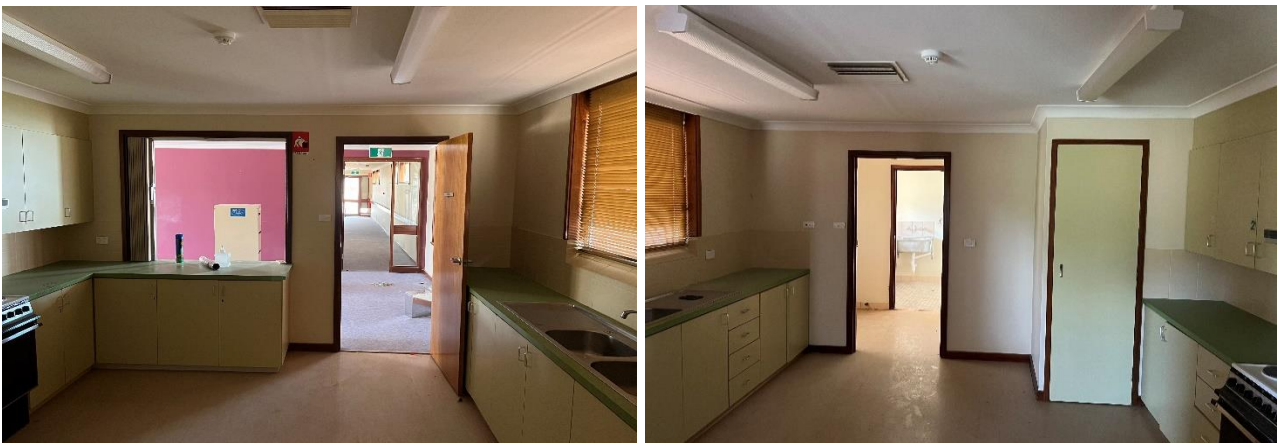
Kitchen:

1. Walls and ceiling require painting.
2. Lighting requires replacement.
3. Cooktop/oven requires replacement.
4. Floorcovering appears serviceable.
5. Kitchen requires commercial cleaning.

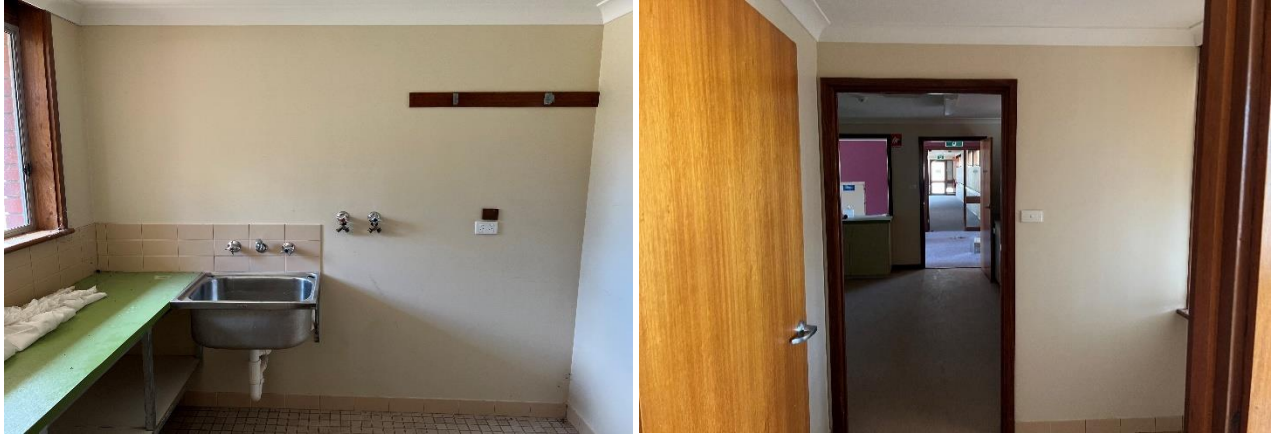
Laundry:

1. Walls and ceiling require painting.
2. Lighting requires replacement.
3. Floorcovering appears serviceable.
4. Laundry requires commercial cleaning.

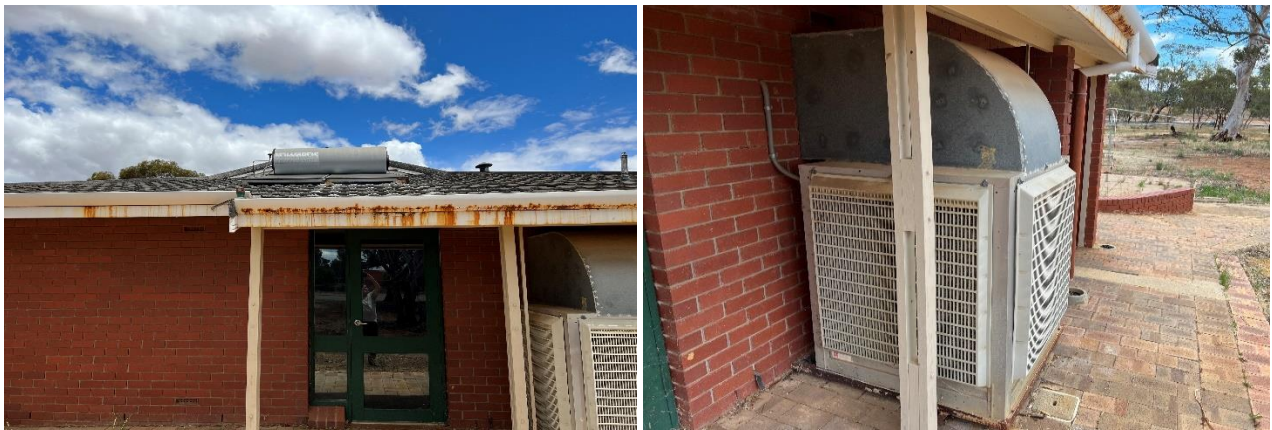
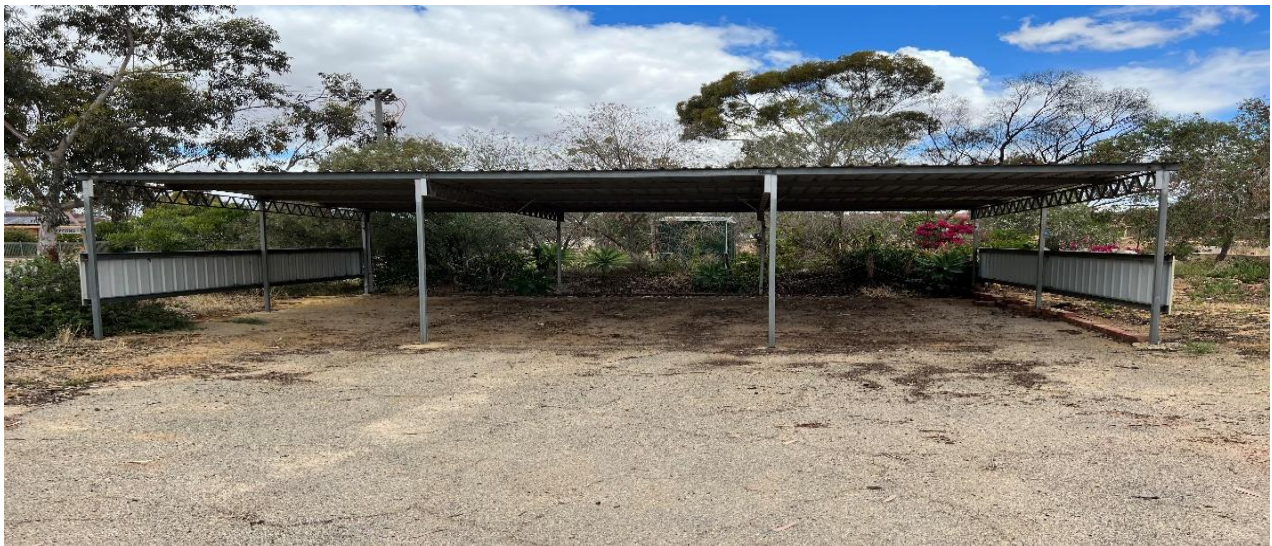
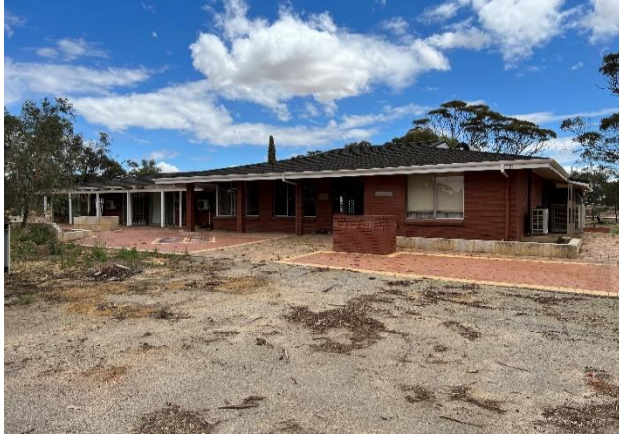
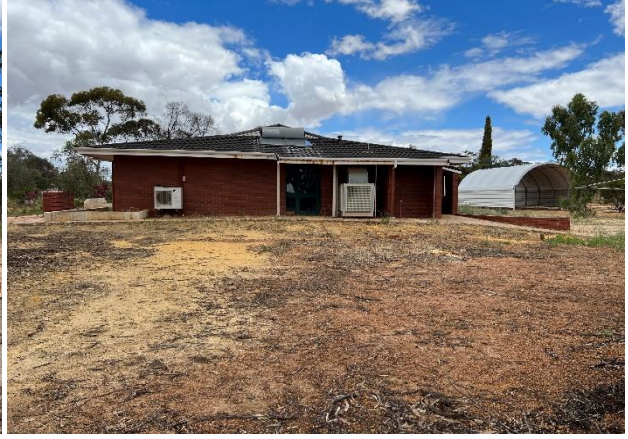
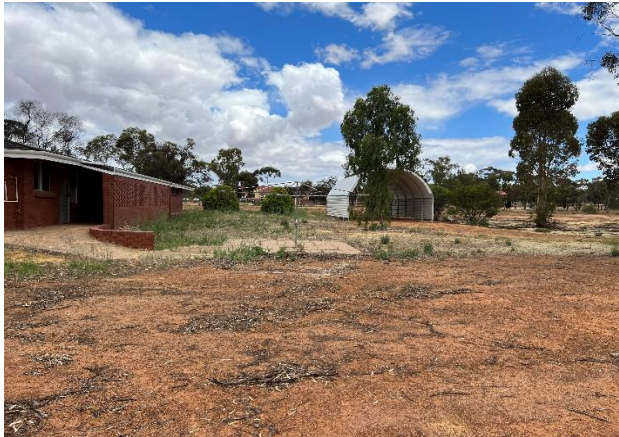
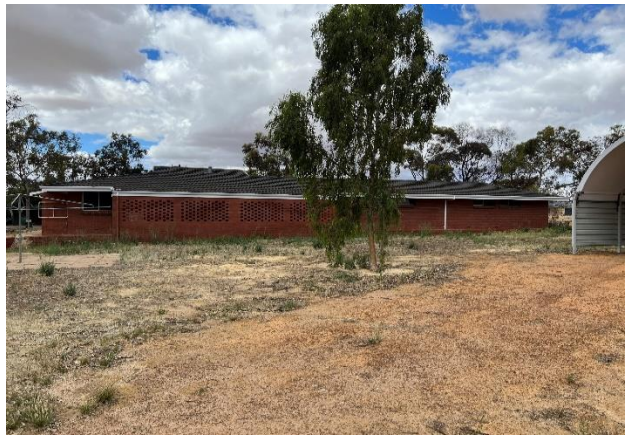
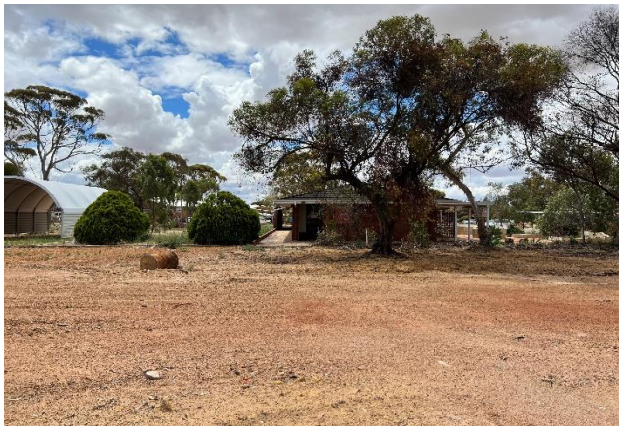
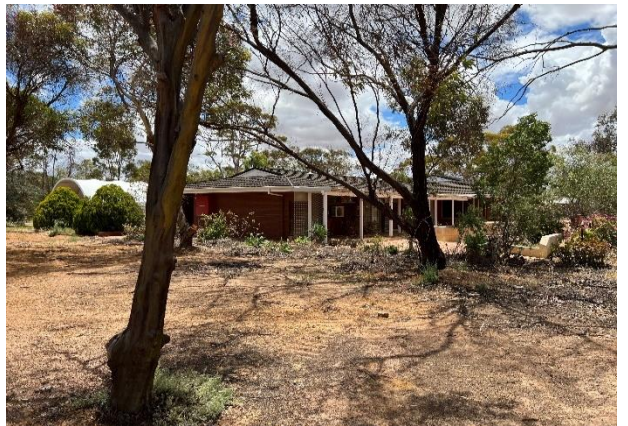
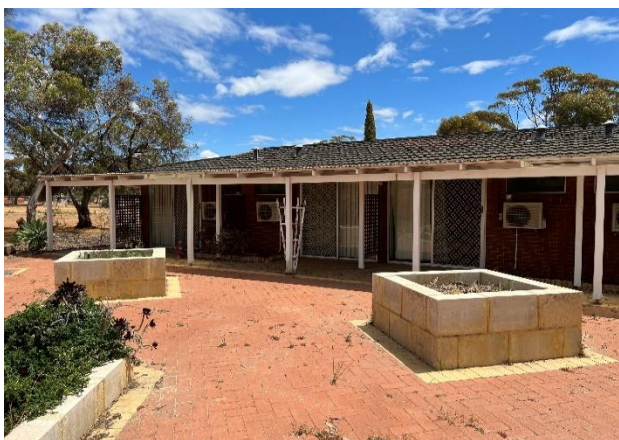
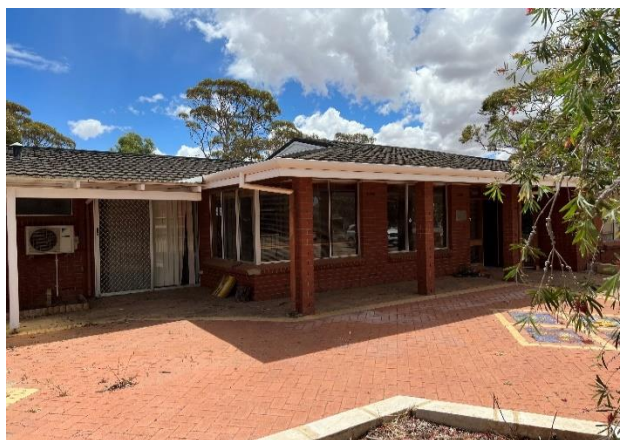
GENERAL:

1. The Solar Hot Water system requires testing however is likely to require replacement.
2. The Evaporative air conditioner requires testing however is likely to require replacement.
3. Electrical services appear to current standards with Residual Current Devices (RCD) fitted however full electrical inspection and report is required.

4. Where damaged, facia and gutters will require replacement.
5. Some external painting is required to maintain infrastructure.
6. External building will require commercial cleaning.
7. Perimeter fencing is required for all four boundaries.
8. The property will require gates for entry/exit.
9. Landscaping has seen significant deterioration since the facility was closed and requires work to reinstate to an acceptable level.
10. Reticulation of garden areas is required.
